Manhole Inspection Summary

Manhole # S15C1_010MH

Insp Date: **5/28/08 2:59 PM**

Location Address: **1628 ellamont-parkman alley**

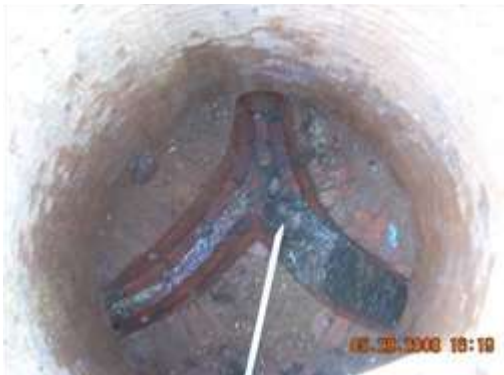
DEFECT 2

Infiltration: ☐ None ☐ Joint ☐ Cracks ☐ Mortar ☐ Roots ☒ **Wall**

INFILTRATION AT BARREL WALL

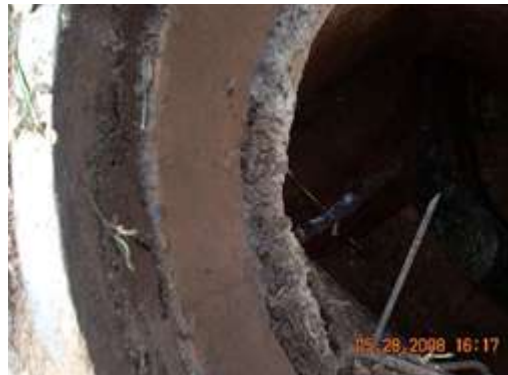
Defect 1

Frame Offset: **1** (in.) Condition: ☒ Sound ☐ Cracked ☐ Leaks

frame offset

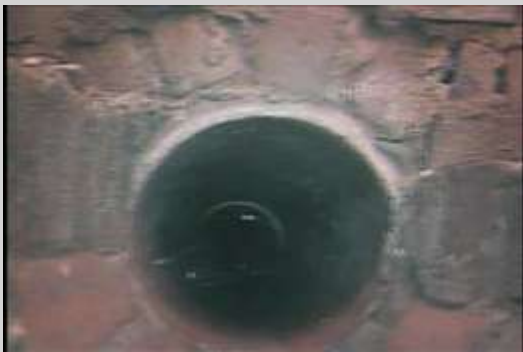
12 O'Clock Outflow

8 in. Circular Gravity Sewer
Pipe Out @ 12 O'Clock

Pipe Height: **8.4** (in.) Rod and Bar (Angled)
Pipe Material: **Clay** ☐ Pipe Lined
Invert Depth: **6.85** (ft.) Flow Characteristics: **Slow**
Deposits: ☒ None ☐ Mud ☐ Sludge ☐ Debris ☐ Grease
Silt Depth: **0** (in.) Deposits Extent:
Infiltration: **None** Pipe Seal Cond: **Sound**

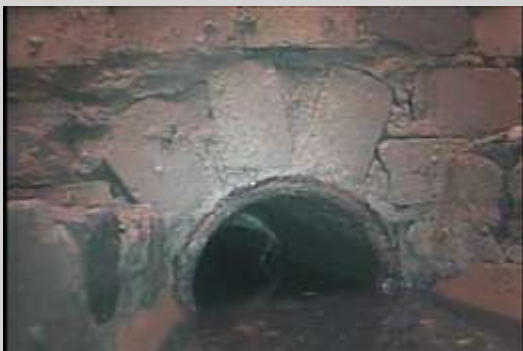
4 O'Clock Inflow

6 in. Circular Gravity Sewer
Pipe In @ 4 O'Clock

Pipe Height: **6** (in.) Rod and Bar (Angled)
Pipe Material: **Clay** ☐ Pipe Lined
Invert Depth: **6.80** (ft.) Flow Characteristics: **Slow**
Deposits: ☒ None ☐ Mud ☐ Sludge ☐ Debris ☐ Grease
Silt Depth: **0** (in.) Deposits Extent:
Infiltration: **None** Pipe Seal Cond: **Sound**

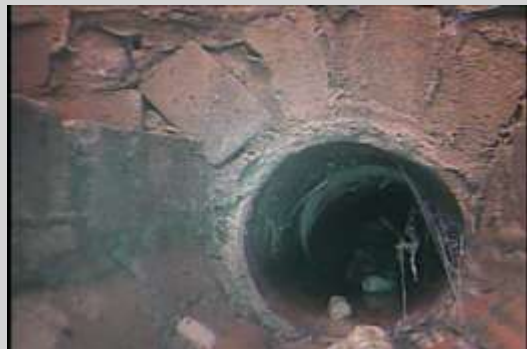
8 O'Clock Inflow

6 in. Circular Gravity Sewer
Pipe In @ 8 O'Clock

Pipe Height: **6** (in.) Rod and Bar (Angled)

Pipe Material: **Clay** ☐ Pipe Lined

Invert Depth: **6.67** (ft.) Flow Characteristics: **Slow**

Infiltration: **None**

Pipe Seal Cond: **Sound**
